### POST-CIVIL WAR ARCHITECTURE

Charles Nelson

Historical Architect, Minnesota Historical Society

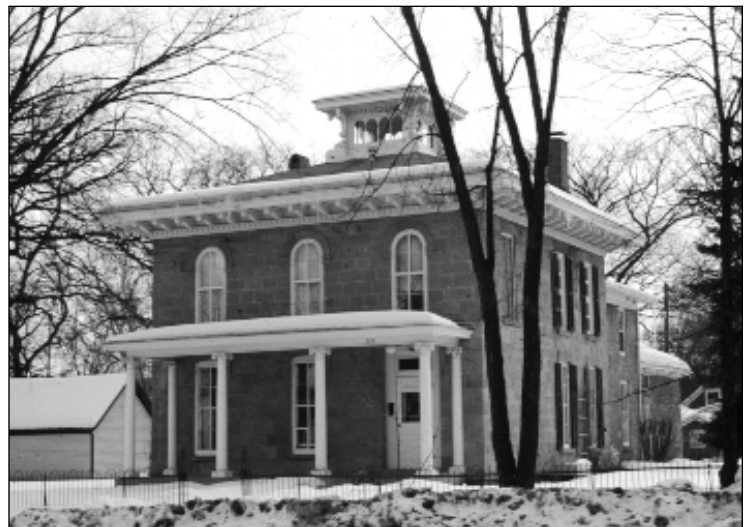
Figure 1, right above: the Thorne-Lowell house in the W. 2nd St. Historic District in Hastings was built in 1861.

The villa as an architectural style was introduced to the masses in Andrew Jackson Downing's popular work, *Country Houses\**, along with Gothic-inspired country houses and cottages. (See Figure 1.) It was loosely inspired by the romantic image of Italian country villas, which are usually found in a natural setting. Its architectural signature was the rooftop cupola or corner tower, along with a rich adornment of brackets—ornamental, scroll-like supports under the eaves of a roof—and classically inspired columns. (See Figure 2.) The villa was exceptionally adaptable as both a country manor and an urban mansion. It was regarded as a statement of social correctness and respect within the community, and it was an exceptionally popular choice by people of prominence. When all things were considered, the Villa Style was a commodious one.

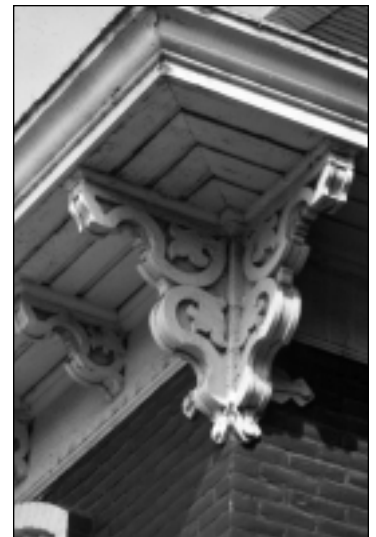
Figure 2, right below: Detail of a bracket on the Archer Hotel in Northfield, built in 1877. The hotel is in the Northfield Historic District.

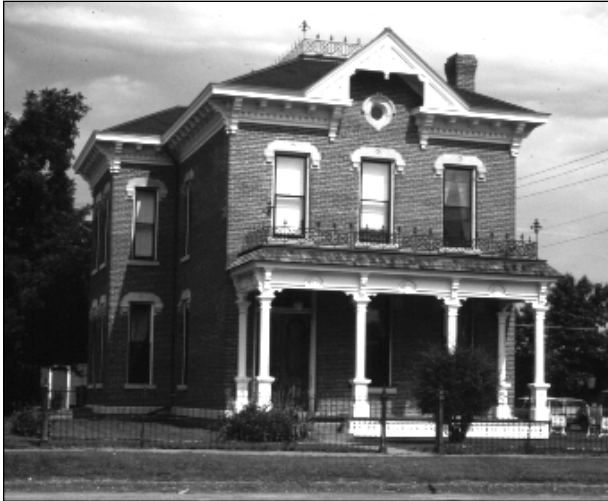
*Figure 3, the Lorenz and Lugerde Gintbner house in Wabasha, listed on the National Register of Historic Places, was built in 1882.*

employ ornamental details such as brackets and columns in pairs. Low-hipped roofs with broad eaves emphasized the massing of the building below. With the exception of the cupola or tower, the Italianate Style incorporates the same ornamental characteristics as the Villa Style, though in greater abundance. (See Figure 3.)

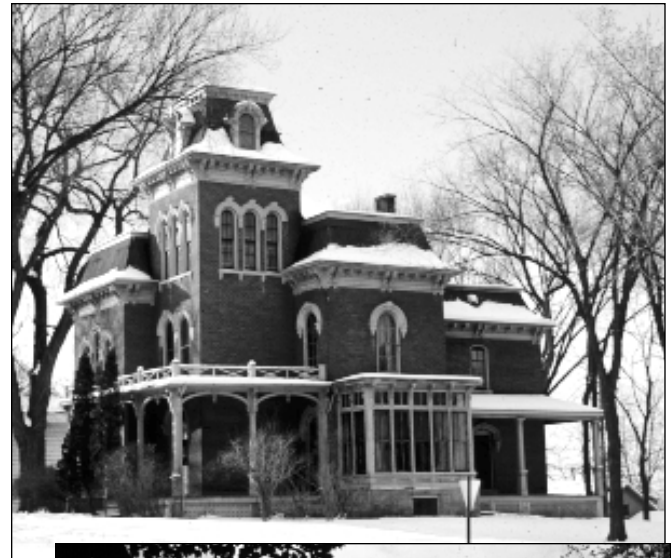
*Figure 4, right above. The Philander-Sprague house in Red Wing was built in 1868. It is in the Red Wing Residential Historic District.*

space. The lower face of the roof is nearly vertical and is most often fitted with dormer windows. It is commonly faced with patterned slate or wooden shingles to produce a decorative effect. The upper pitch is very low and, due to the height of the lower face and the use of a cornice or curb, is nearly obscured from view. An ornamental treatment of the curb is created by the addition of a filigree iron cresting, similar to a small fence. The roof and its ornament emphasize the height of the building. It was also common to incorporate a tower (with mansard roof) on public buildings and prominent residences. With the exception of the mansard roof, other details are similar to those found in the Italianate Style. (See Figure 4 and Figure 5.)

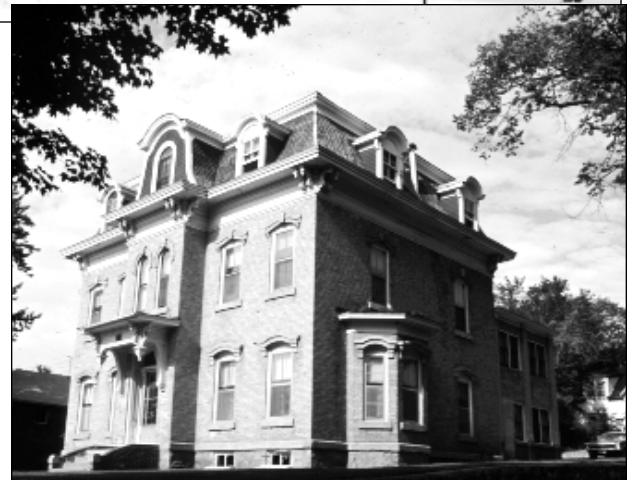
*Figure 5, right below. The Van Dyke-Libby house in Hastings was built in 1867, and is listed on the National Register of Historic Places.*

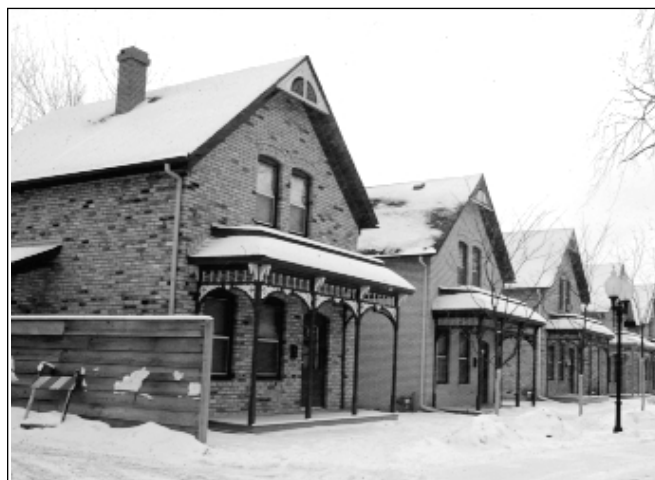
Figure 7. Part of the row of houses on Milwaukee Avenue in Minneapolis, built 1883-86, part of the Milwaukee Avenue Historic District.

Style. It was a simple house to satisfy the needs of small working-class families. It was hastily constructed on a narrow city lot, using a standard plan and mass-produced materials. Mechanics cottages commonly were erected in rows or groups in subdivisions called "rearrangements" to accommodate concentrations of buildings. Each cottage was identical to its neighbor. (See Figure 7.) Due to the haste and relatively low quality of construction, few Mechanics Cottages survive, and very few survive in their original groups. (Milwaukee Avenue in Minneapolis, listed on the National Register of Historic Places, is a rare example of an original row of Mechanics Cottages.)

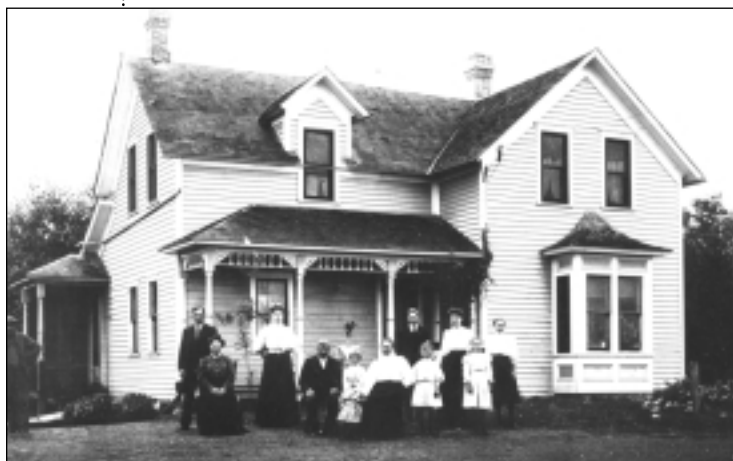
Figure 6.  
The Peter Roggurbush family house, Lac Qui Parle County, ca. 1895.

Minnesota. It is often considered the predecessor of the American Four-Square or Corn Belt Cube of the early 20th century. The structure often began as a subsistence dwelling. As the owner prospered, a more impressive story-and-a-half addition would be constructed at right angles to the initial structure, resulting in the characteristic "L" or "T" shape. The addition often contained bedrooms on the second floor and a parlor/sitting room on the first floor. (See Figure 6.) The original structure was adapted to serve as kitchen and dining space. In many early examples of this building type, the difference in the construction of the two

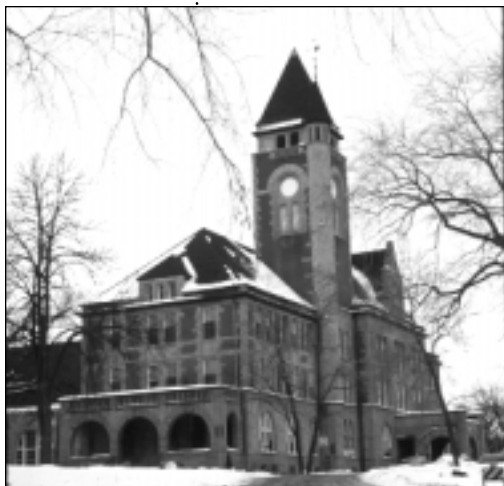
Figure 8. Administration Building of the Minnesota State Training School, Red Wing, 1889. Note the semi-circular “Syrian” arches. The school is listed on the National Register of Historic Places.

Although this period is widely known as the "Brownstone Era," the term is rather misleading in the context of Minnesota architecture. Virtually no brownstone is found in Minnesota. In essence, the term has been commonly taken to refer to any "rock-faced" masonry building, whether it be of limestone, sandstone, quartzite or granite. These buildings were popular during the 1880s and 1890s. They were usually large buildings, including mansions, churches, courthouses and public buildings. If any generalization can be made, it may be stated that the style and medium were not adaptable to small-scale buildings. (See Figure 8 and Figure 9.)

Characteristics of the style include a strong sense of massiveness, rusticated or rock-face masonry, low semi-circular arches (often called Syrian arches), elaborate carvings, polychromatic panels, towers, and steeply pitched slate or tile-clad roofs. Bands of windows were often divided by clusters of small pilasters called colonettes. Interiors were remarkable for their use of intricate detailing, fine materials and decorative opulence.
